Old English Car Club – Central Island Branch

July 1, 2020 Virtual Restoration Fair

Projects underway, completed, issues at hand:

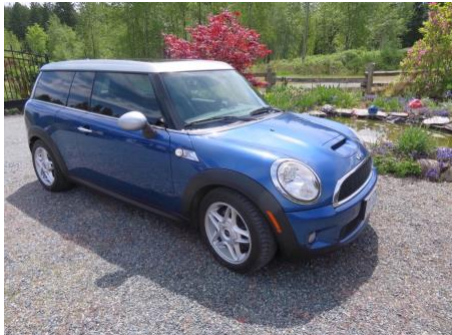
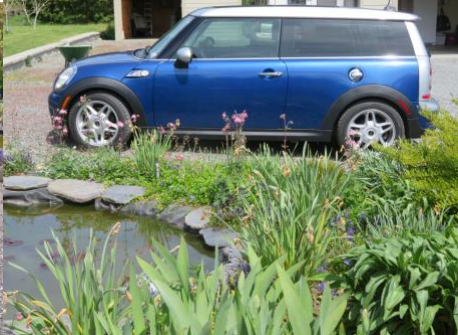
<u>Malcolm Hargrave</u> 2008 Mini Cooper S	<p>May Update:</p> <p>Just to let you know that I have now finished both of my restoration projects, and there are no plans for any further exhausting or time-consuming restorations.</p> <p>Phase 1 was to wash and wax my car, Phase 2 was to wash and vacuum the inside.</p> <p>Here are photos of both completed phases.</p> <div style="display: flex; justify-content: space-around;">

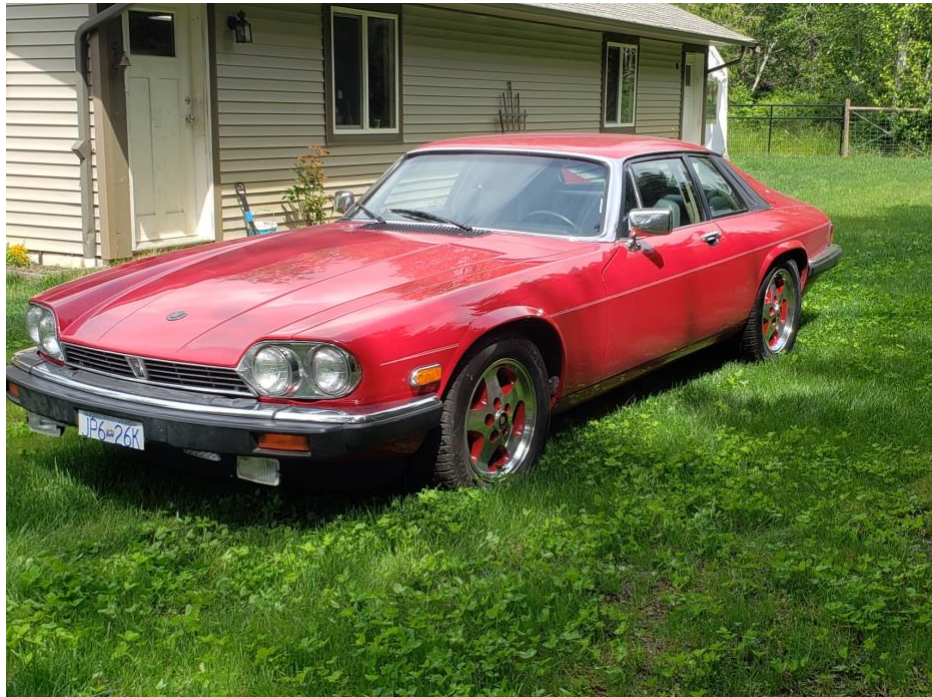
Big Red finally rolled out of the shop after getting some cosmetic and mechanical upgrades.

She is now sporting uprated Jaguar 16-inch refurbished wheels with new tires, daytime running lights, new front shock absorbers and front brake pads.

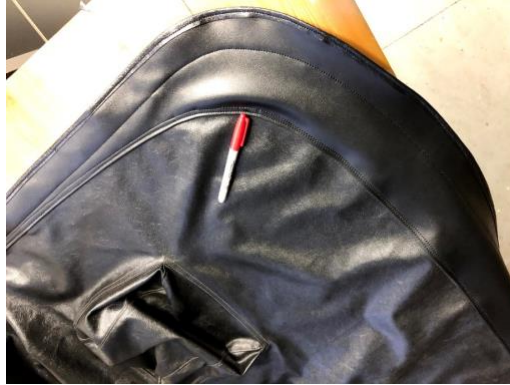
This worked out well but as you can see in the photo we were left with puckers at the corners in the rear. This is partly to do with the new fabric convertible top creating a hump the tonneau has to wrap over. We opted to do a modification and cut a slit in the corner and with the use of bias tape remove the pucker. The next photo shows the result. We were pleased with this adjustment.

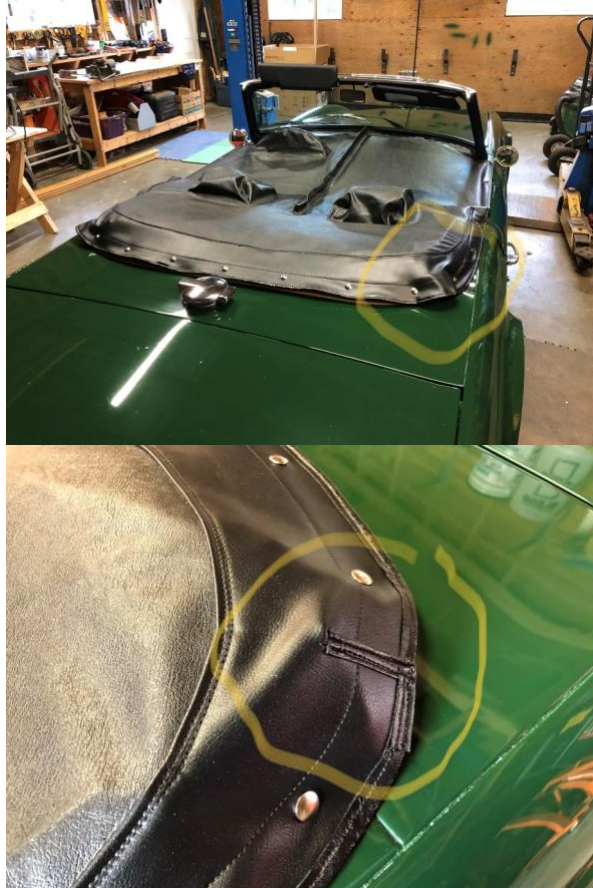
I ended up having to redo all the snap locations except 2, even those on the doors, as they just didn't quite align. By removing the old snap and sewing a small reinforcement patch we could install the new snap in the right location. We even ordered a grommet tool from Amazon and replaced 2 of the dashboard grommets that had been damaged by

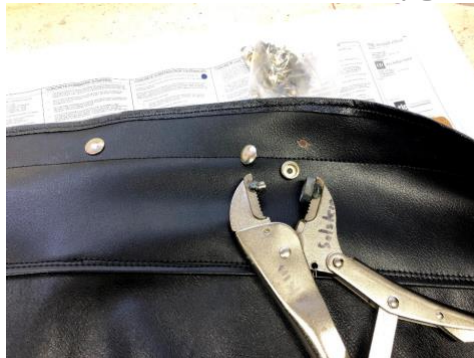
trying to stretch the original tonneau. We already owned a snap attachment press tool – see photo of the vise-grip pliers with custom jaws. We use this tool a lot on our boat with very good results.

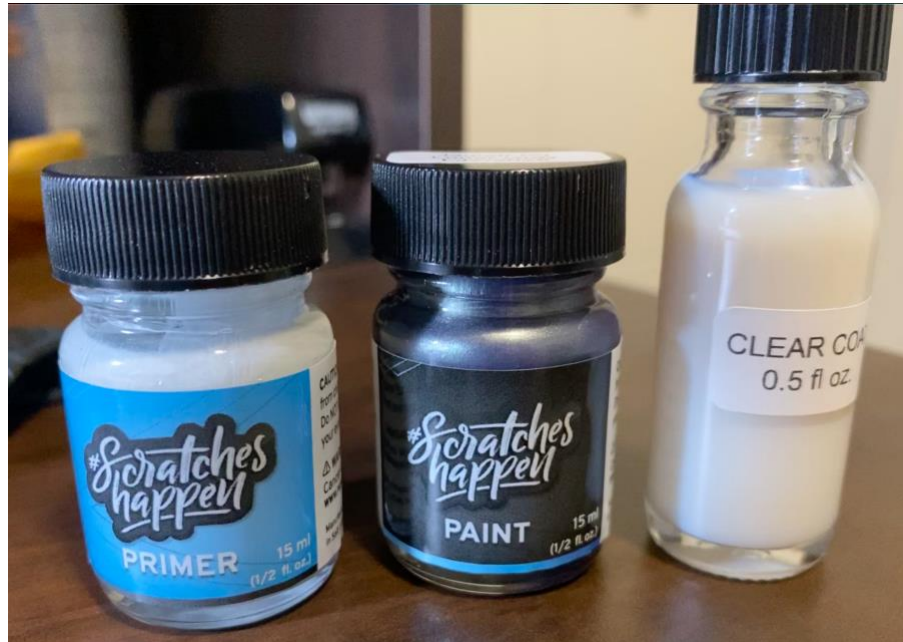
A couple of small scratches I wanted to address on the 2007 XK, I purchased a colour match at Scratches Happen online and received a kit of primer, colour paint, clear coat, several brushes and small foam tipped sticks, gloves and a card to "play with the paint flow and colour match" before getting brave enough to splash colour on the car. I'll keep you posted as to how this works out.

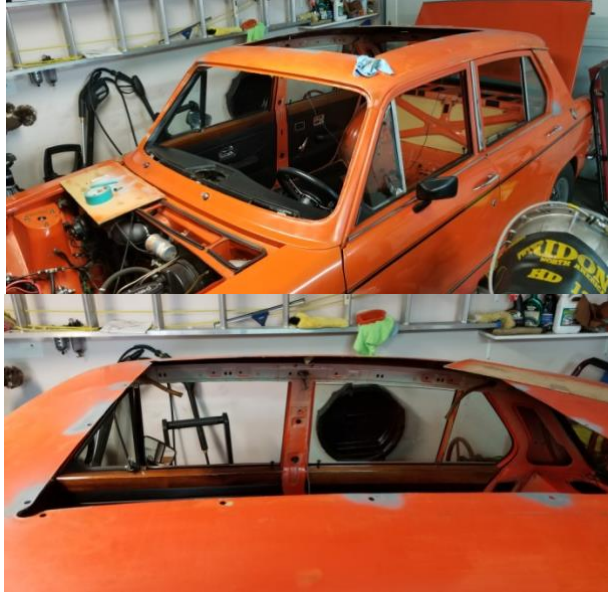
Job 3 Peel off the old Vinyl roof from the car and then peel off the vinyl from the sun roof Cassette and the sliding roof panel. Removed all the old glue from car roof and sun roof, vinyl on the C-pillars was also removed along with the glue. We had to ensure that there was no glue lumps or bumps left behind as this will show up on the new vinyl.

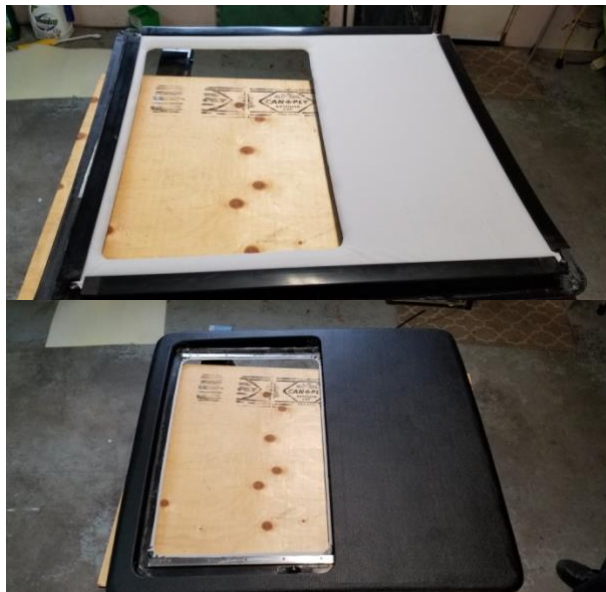
Job 5 next using the extra vinyl that was shipped we glued up the top of the cassette roof and the top of the sliding roof panel. Glue was applied to both the metal surfaces and the vinyl surfaces. Stretching the material with one person at each end we gently laid the vinyl down onto the roof panels. This has to go down right first time due to the spray glue we were using is not forgiving if it is wrong. Careful trimming is needed when trimming at the corners to prevent any bulk vinyl that would not allow the sunroof to slide or the cassette to sit right down when reinstalled on the car.

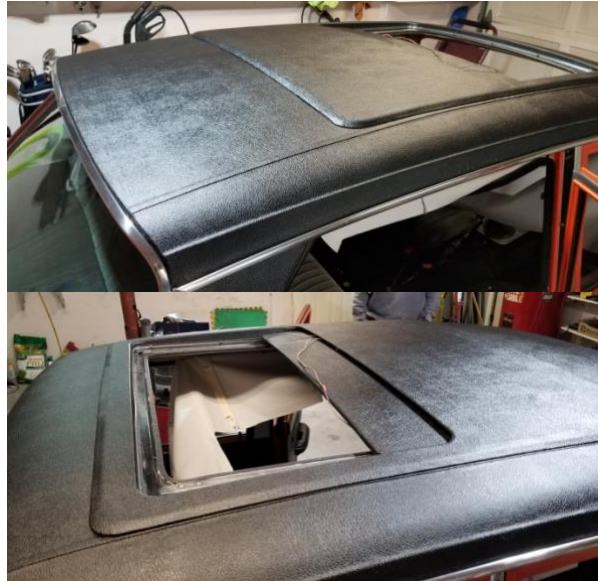
Job 7 Sunroof was reassembled before fitting the assembly back into the car. Now the car has matching vinyl on the car roof and the sunroof. When the vinyl was pressed right down into the gutters and windscreen aperture, excess vinyl was trimmed off and chrome gutter moldings refitted.

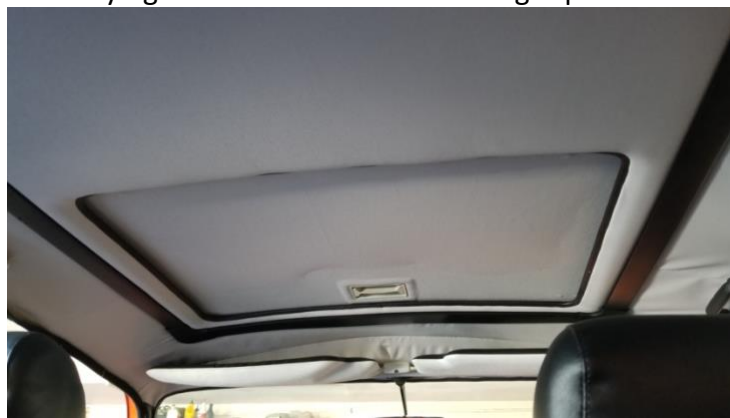
Final Tasks for the refurbishment of the Sprint headliner and vinyl roof. The Head lining was fitted after the sunroof was installed in the car, this was because there was a lip around the sunroof perimeter that the headlining material tucks into then it gets four black trim sections to clip over the lip. Getting the headlining tucked in under the rear window rubber proved to be a challenge, certainly easier if the window gets removed first. Tucking the sides of the headlining around the door frame was an art and it is held in place with the rubber door seals. Once the headlining is stuck around the front windscreen aperture, the sun visors and the interior mirror had to be reinstalled. Much difficulty arose trying to locate the holes in the right place.

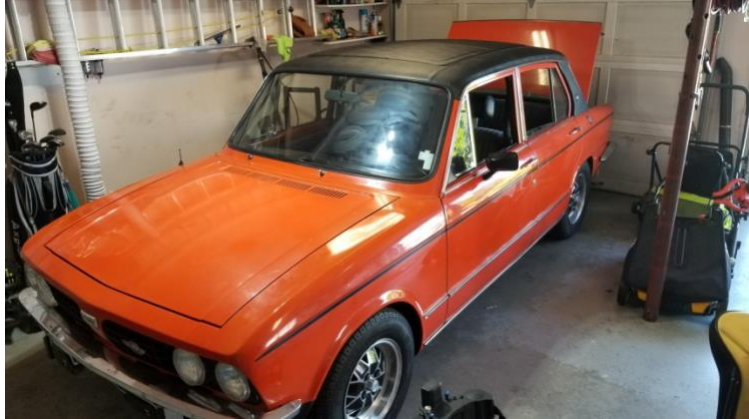
<p>Finally, when the headlining is all installed, the windscreen was refitted using string around the outside rubber surround and windscreen sealer caulked in the rubber surround.</p> <p>Last job was to remove any baggy parts in the headlining using a head gun. This worked out really well thanks to help from Doug and Judy's experience with material.</p> <p>Job completed and looking very smart.</p>

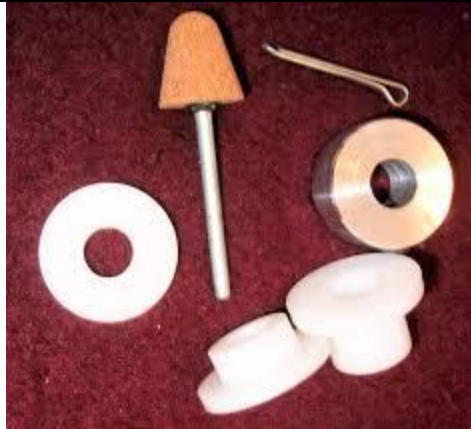
<p><u>Ken Hedges</u> 1968 Triumph TR250</p>	<p><u>May Update:</u></p> <p>A while back, I thought I would do some cleaning on the engine bay of the Triumph, and started to poke around areas that don't get too much attention, and found that the bushings in the firewall that the accelerator rod passes through where cracked and falling apart, it should have occurred to me earlier that something was wrong as it took more travel on the gas pedal to rev up the engine.</p> <p>If anyone has a TR 4, 4A, 250 or TR6 and had to replace these bushings in the past knows it is just about impossible with the engine in place, even after getting the bushings installed, threading the accelerator rod through in the footwell is also next to impossible.</p> <p>So I started to look around on the internet for other solutions, and found an answer to installing the bushings an easier way, they are not like the original design, and can be slipped in easily from one side. I got the idea from a picture on the web. (I should have taken pictures of the ones I installed.)</p>

As I was impatient to get the job done, I asked a good friend if he could make me some, again I found a drawing of the bushing on the web, emailed it to our friend, the next day an envelope with the parts were delivered to our front door.

The installation went perfectly, and with a little tightening up of the carburetor linkage all is fine again.

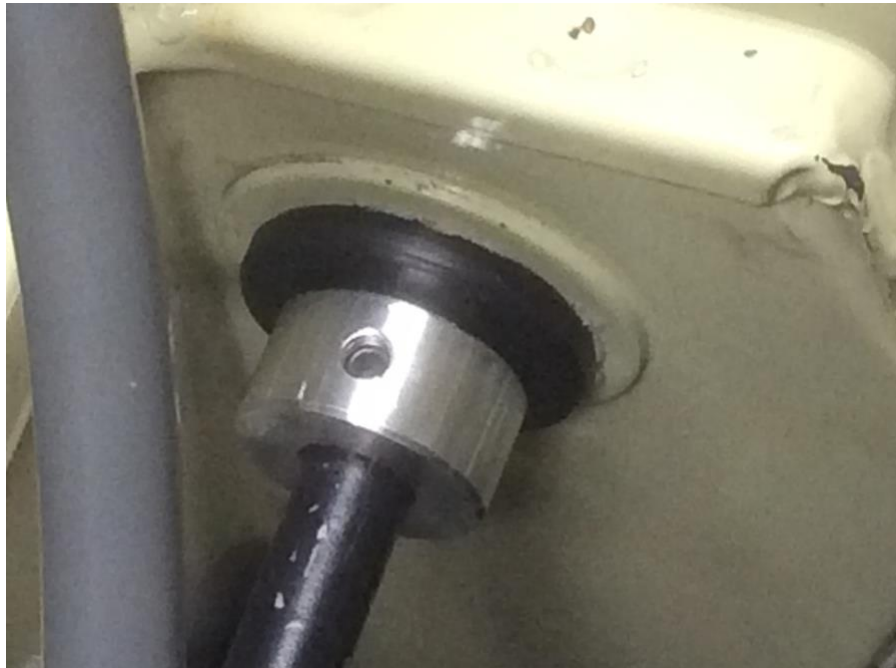
The above picture shows the driver side (LHD) bushing installed with the locking collar which holds the bushing in place.

Although it is not original it solves a very hard and frustrating repair.

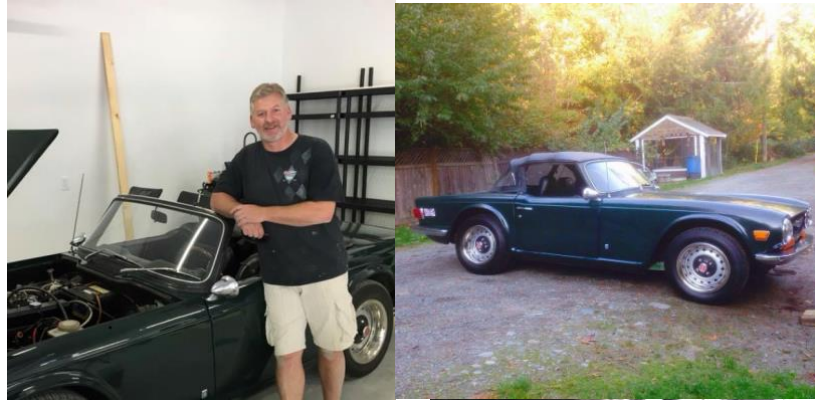
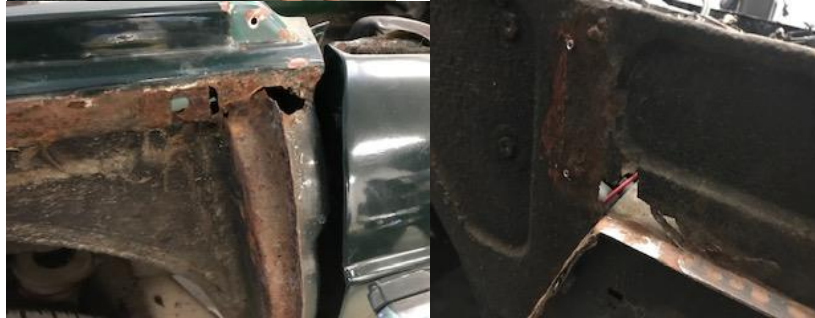
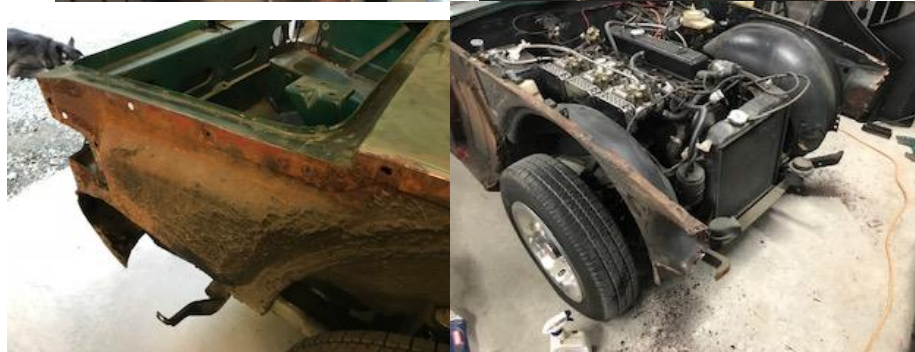
She has always been a BC car and it shows a little for sure. Above are a few pictures of the corrosion and below, the start of the repairs to the bodywork.

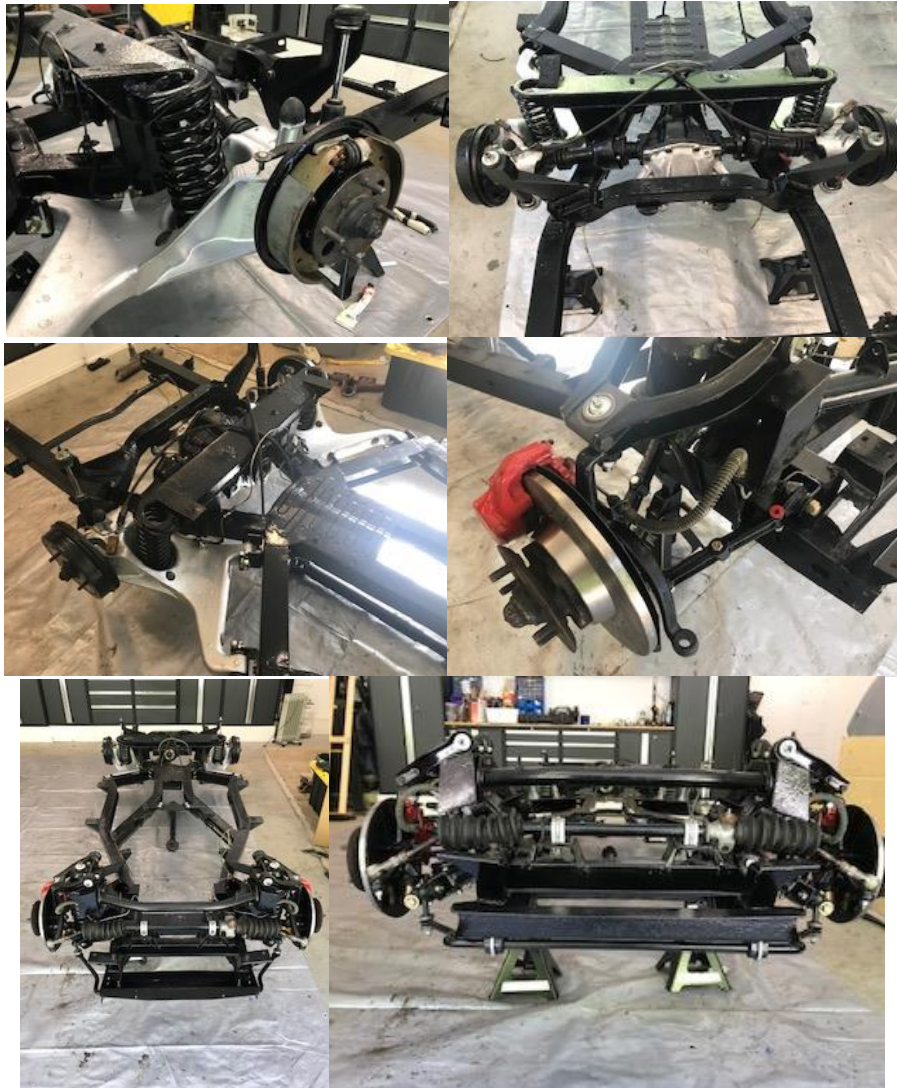
New HD spring and shock absorbers front and rear. Nylon bushes all around, trailing arm adjusters, track rod ends, ball joints, fulcrum pins, Trunnions, drilled and slotted rotors, front pads, bar links, rear calipers

and shoes, all existing parts blasted and recoated. Also, differential oil seals replaced - I didn't enjoy changing them!

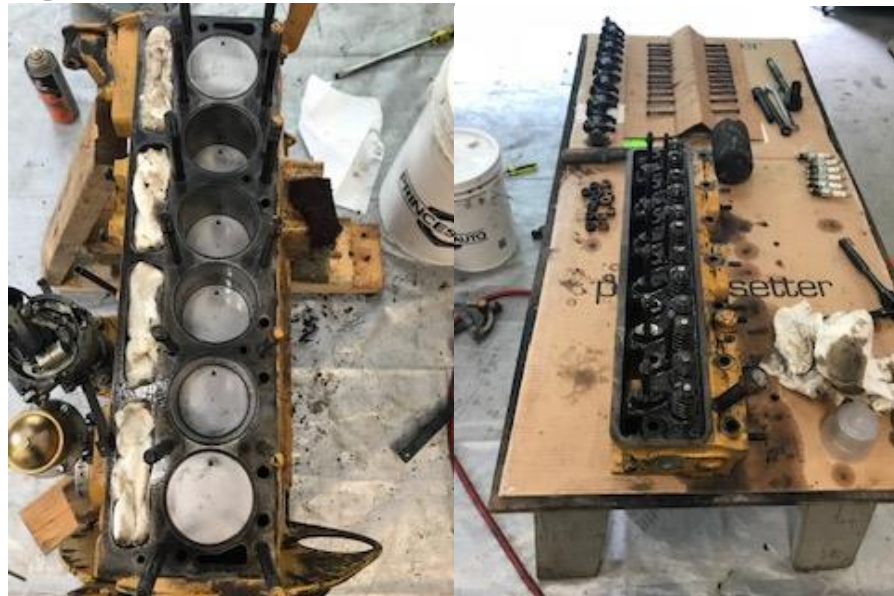
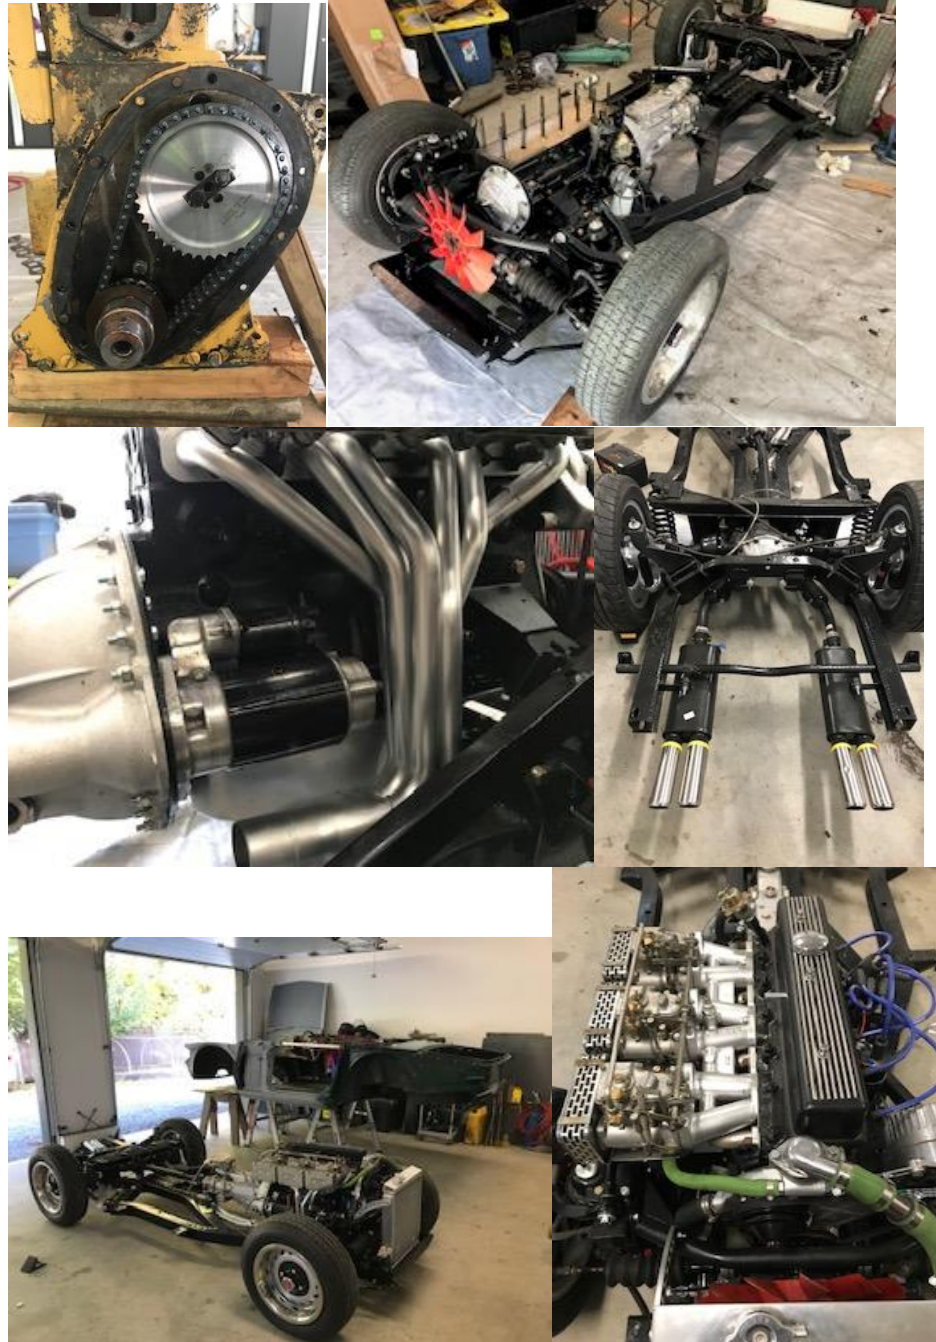
Having removed the engine, I sent it for inspection. Unfortunately, the block was done, too much wear around the camshaft guides, but the head was good. So, I began the search for a replacement block. I was fortunate enough to find one in Coombs. It had been rebuilt a few years before, the block had been bored out oversized to 20 thousandths of an inch, with new pistons and rings. The guy had receipts for over \$4500 he had spent on it, also had a reground fast street cam installed at the same time, with double valve springs installed in the cylinder head. Apparently, the back end of the car kind of collapsed a few months after the rebuild and had been parked up for five years. I took a bit of a risk and bought it as a full long block, at least it was very reasonably priced. I removed the head and sent it to Island D for new hardened valve seats and machining down to 3.400 thick, which should give me around 9.75 : 1 compression. The bores in the new block were in great shape, so I just honed them out. I put it all back together and all is good! Great oil pressure and sounds great, with one exception - a bit of a dieseling issue, which I haven't quite figured out yet. Yellow engine paint was a bit dodgy, I couldn't live with that, so stripped it and repainted with black engine enamel.

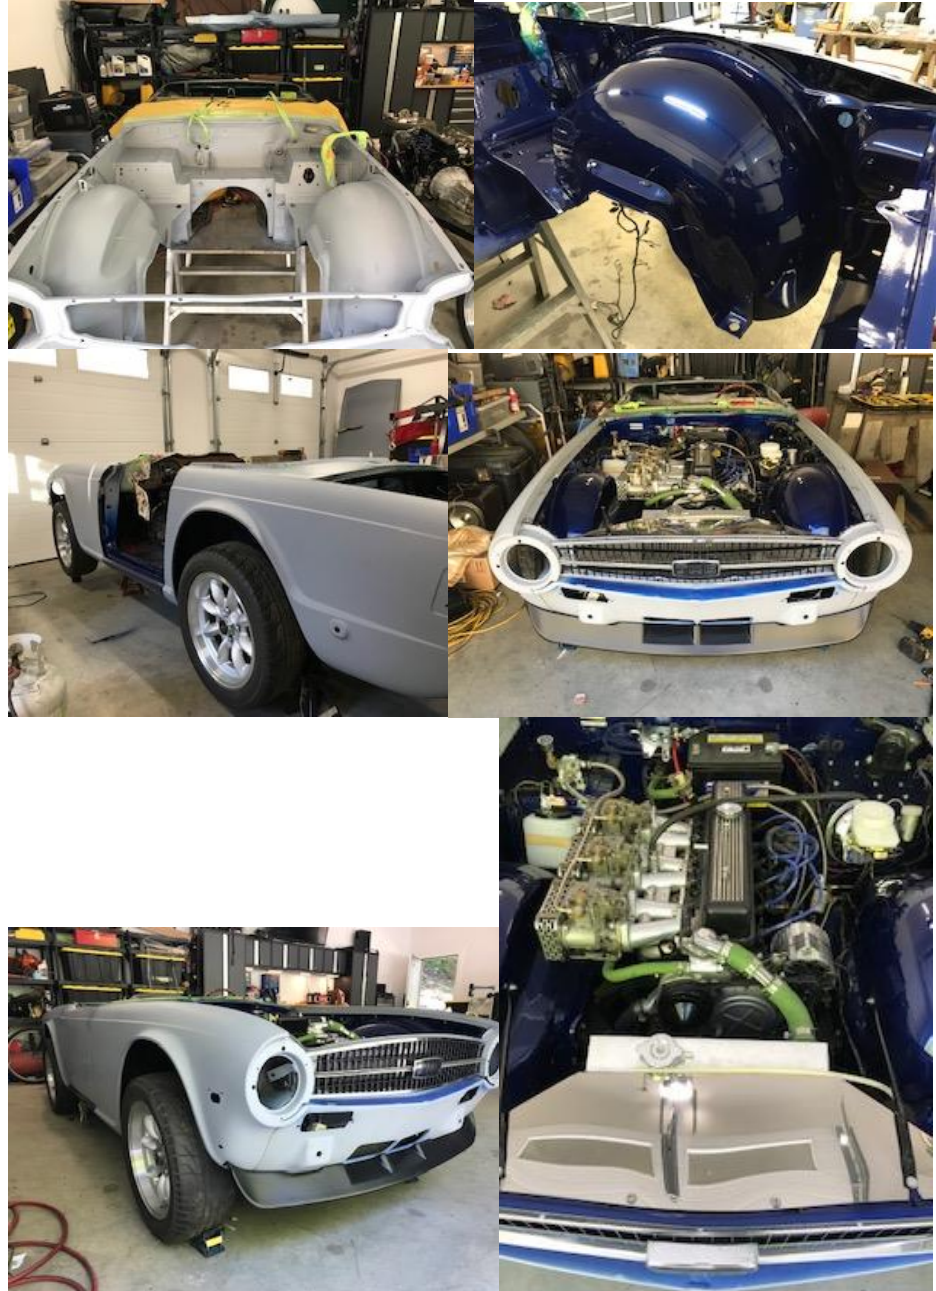
Now that I had the rolling chassis complete and engine running, it was time to get back on the body work, before re-fitting the body back to the chassis and starting the alignment process all over again. It went together fairly well with no major problems, also I forgot to mention I fitted a fresh clutch and thrust/release bearing before mating a rebuilt J type O/D transmission. I found a set of used but great condition 16 x 7 Panasport wheels, which I think look great, but I need to put the correct tire size on yet.

This is where the project is at right now. Hoping to paint her this summer and get back on the road as soon as I can!

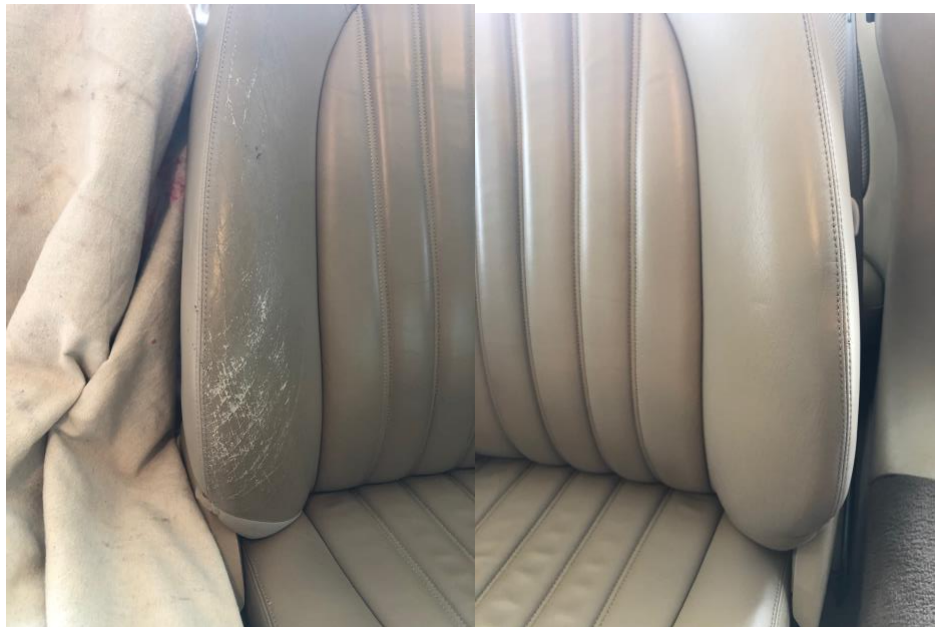
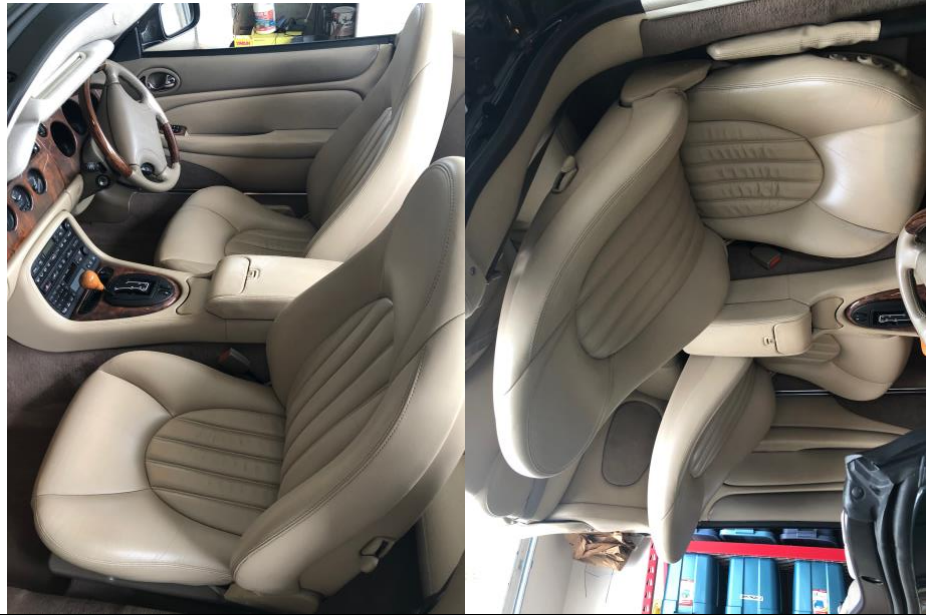
I just purchased a 90,000 km, one owner 2000 Jaguar XK8. Although the car appears to have been well looked after, the front seats were another matter. Not sure if I wanted to spend the money to have them reupholstered, I remember Steve Roebuck mentioned a company that reconditioned his seats about three years ago.

New Creations has an office in Nanaimo that I contacted to inquire about the process. Within three days, Drew, a technician with the company arrived at my house and within a couple of hours completed the transformation. With a history of being an automotive detailer before joining New Creations, I really appreciated Drew's attention to detail.

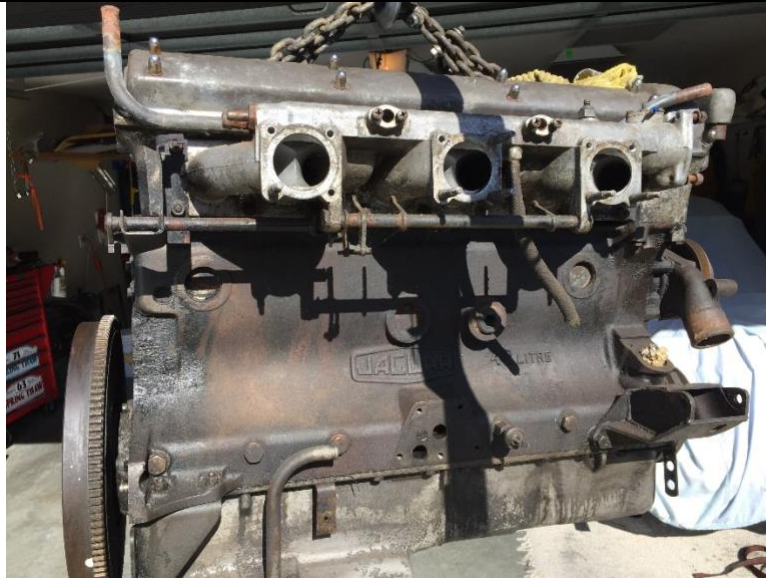
Figure 1 4.2 block prior to clean and stripping

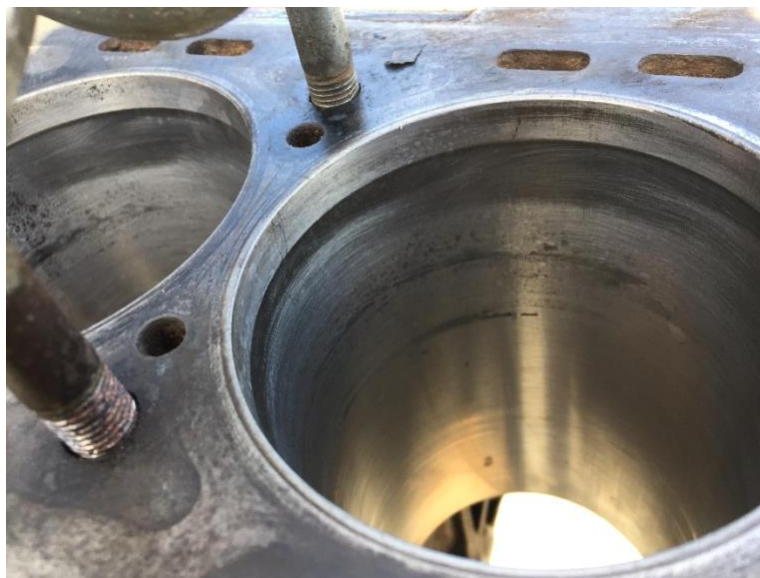
However, the bores did not look too good, a 20-thou lip was at the very top of the cylinders so a rebore looked imminent.

Figure 2 Head removed showed a 20-thou ridge at the top of the cylinder.

I was now faced with a major rebuild of the engine, from a crankshaft grind to a rebore and new pistons.

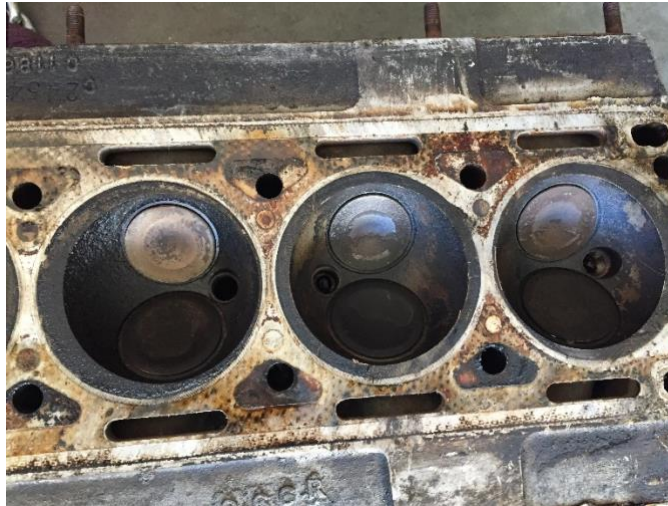
The flywheel, exhaust and inlet manifolds, water pump, and engine mount were no use to me, also I was faced with an alloy sump which bulged out on both sides, which was going to interfere with the exhaust manifold of the 150 on the left side. First a good clean and then a strip down revealed an excellent cylinder head with no cracks or corrosion to the alloy water jackets.

Figure 3 Combustion chambers and water jackets

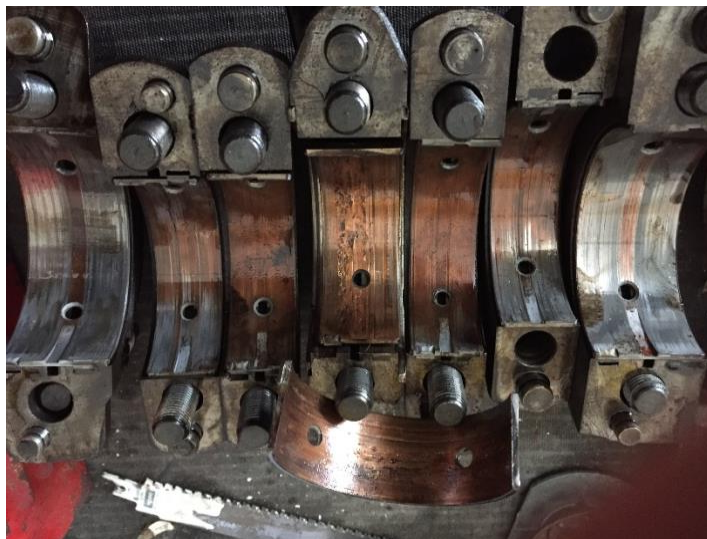
The big end shells were the worst I have ever seen in all my years of being a mechanic and messing about with classic cars.

Figure 4 Big end shells, what a letdown.

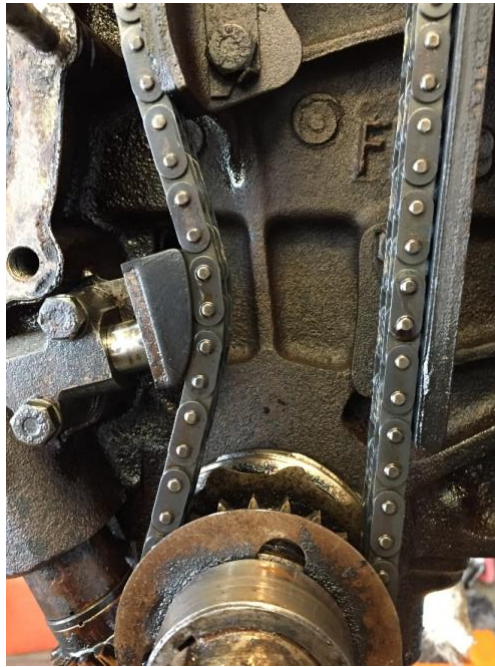
And here is a picture of the very tired and stretched lower timing chain, and how far the hydraulic tensioner is pushing, it is almost ready to pop out.

Figure 5 Tensioner almost at its maximum position.

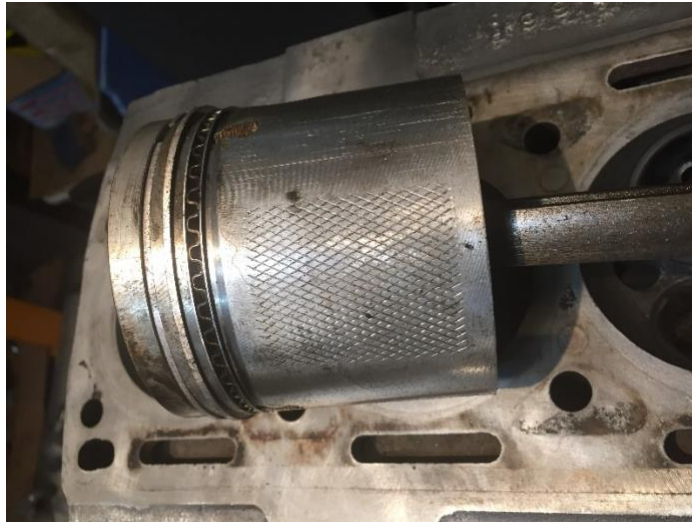
It seems the previous owner had left the engine in the vehicle and only replaced big end bearings, and pistons and done a cylinder head job. More on the head later. The pistons I removed had hatching on both sides, and I was told this is what one did to make the pistons slightly fatter to fill in for the worn cylinder.

Figure 6 Removed piston showing hatching on both sides on all pistons.

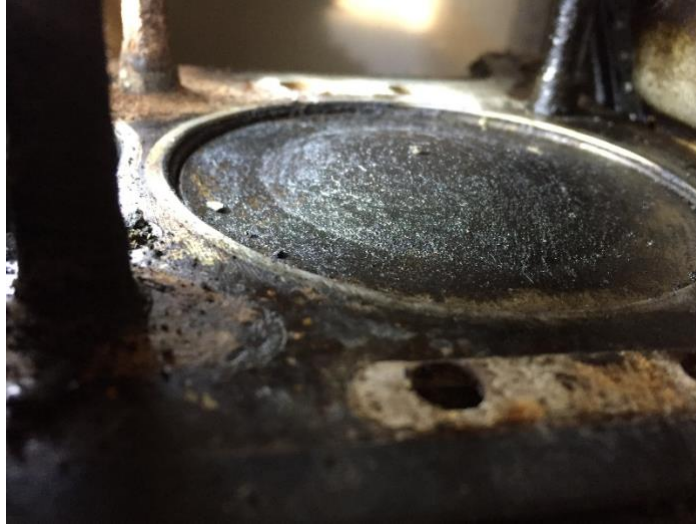
I also noted that the previous mechanic/owner had installed new pistons, but they were either 7 or 8-1 compression rather than 9-1 (see picture below) which the 4.2 engine should have. They were probably wanting to use regular 87 octane fuel rather than the more expensive 91 octane.

Figure 7 Very low dome height indication either 7 or 8-1 compression

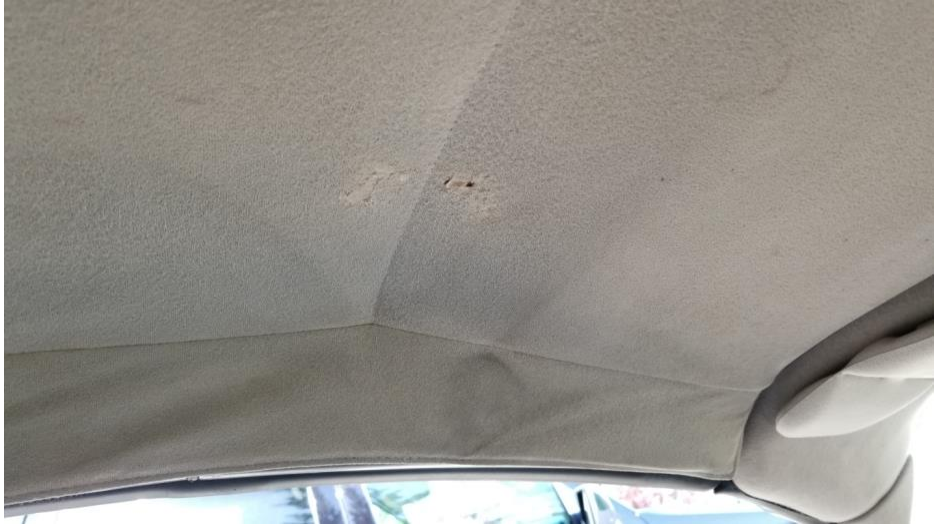
My headliner has suffered like a few other XK8 owners have reported, with rust colored marks on the inside of the convertible top headliner. These are mostly around the rear window glass and both sides of the headliner just behind the rear quarter windows.

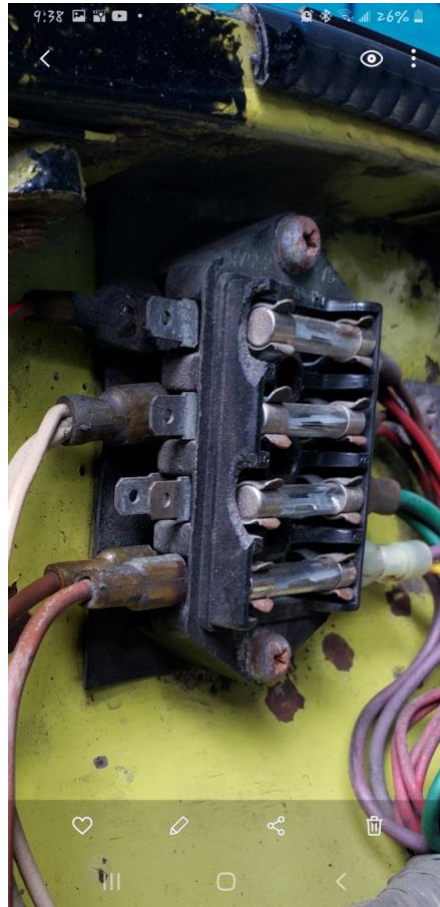
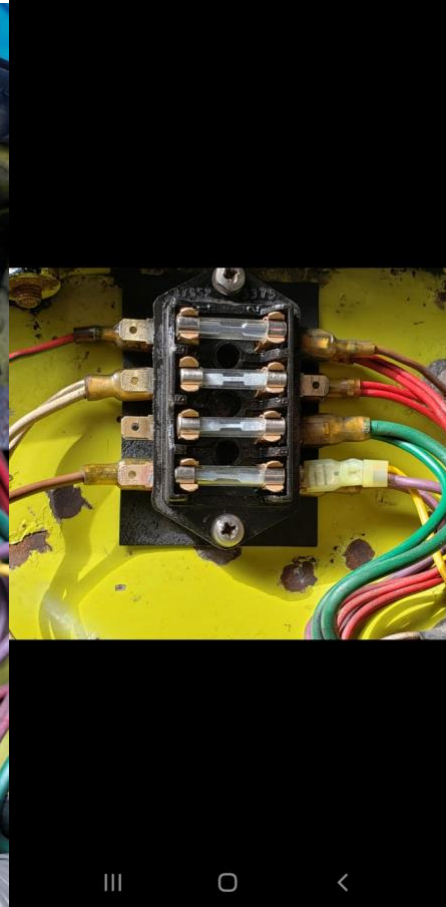
Before

and after

with Salt, Vinegar and Baking Soda & Water

I used a small container of vinegar (old pill bottle) with as much salt as I could get the vinegar to absorb to soak the connector ends in. After about 30 seconds I used an abrasive sponge and/or a brass wire brush to remove the remaining grime. Afterwards I dipped the ends into the second container of water with as much baking soda as the water would absorb to neutralize & stop the cleaning action of the salt and vinegar. Then wipe and make sure thoroughly dry before reconnecting.

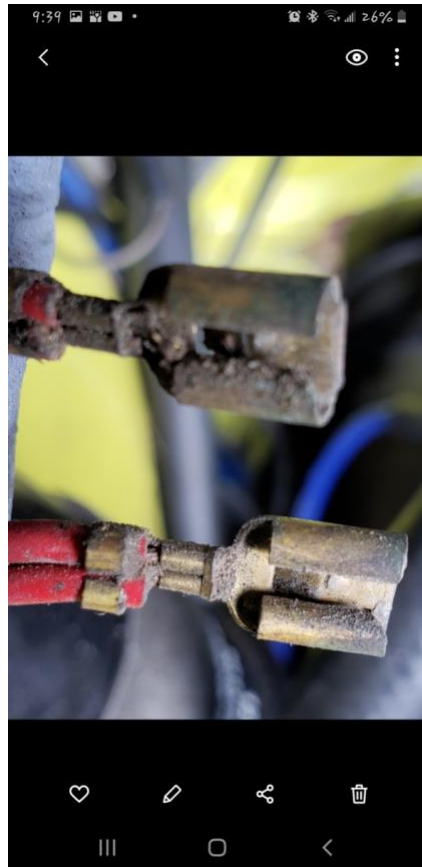
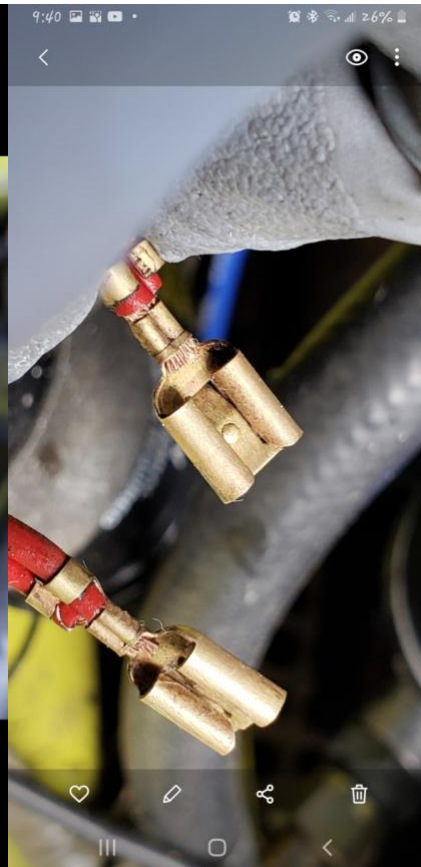
Before

and after

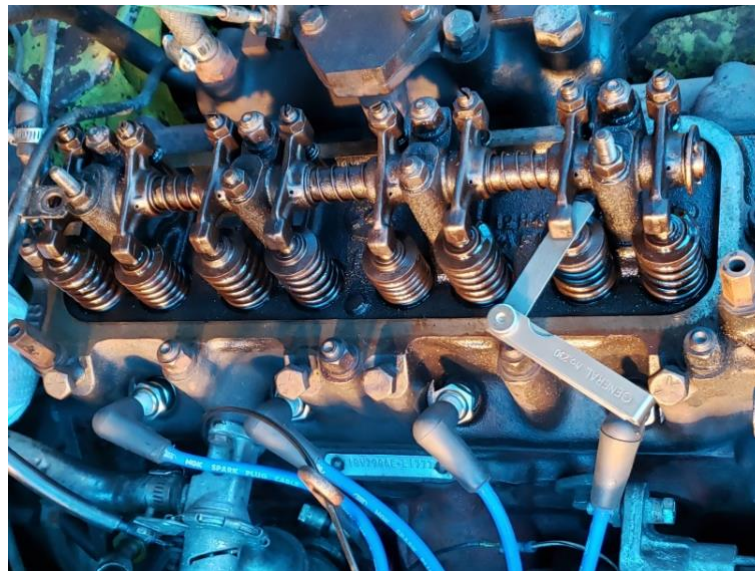
On to the next project.....setting the valve lash.

All but one needed adjustment!
